Subject: Information Report, NHTSA No. 99V-055.002

DEFECT INFORMATION REPORT

DATE: May 26, 1999
FREIGHTLINER CAMPAIGN NO: FL-231
NHTSA NO: 99V-055.002

May 1999
FL231ABC U.S.
FC131ABC Canada**ATTENTION: SERVICE MANAGER****Subject: Meritor Automatic Slack Adjusters****MODELS AFFECTED:** Freightliner, Sterling and Freightliner Custom Chassis specific vehicles manufactured in January 1999, which were equipped with Meritor automatic slack adjusters (ASAs).**GENERAL INFORMATION**

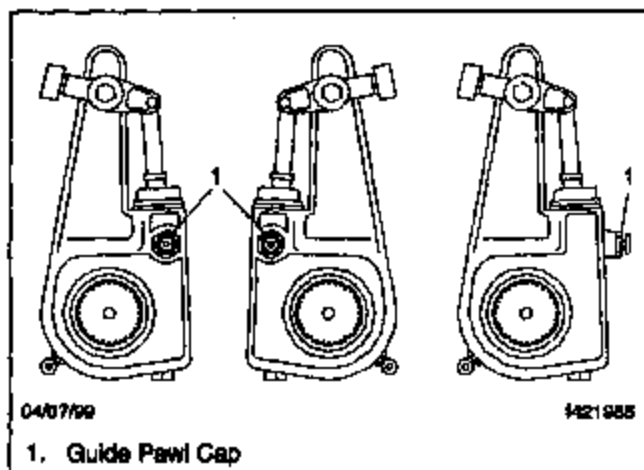
Fig. 1. Possible Guide Pawl Locations

NOTE: The location of the guide pawl can vary. See Fig. 1.

2. Using a torque wrench and 3/4-inch (9-mm) socket, tighten the slack adjuster guide pawl caps 15 to 20 lbf-ft (20 to 27 N.m).
